Re: Revere Copper and Brass, Detroit, Michigan  
TDD #5-8709-08

REVERE COPPER AND BRASS  
SITE ASSESSMENT  
DETROIT, MICHIGAN

TDD NO. 5-8709-08

January, 1988

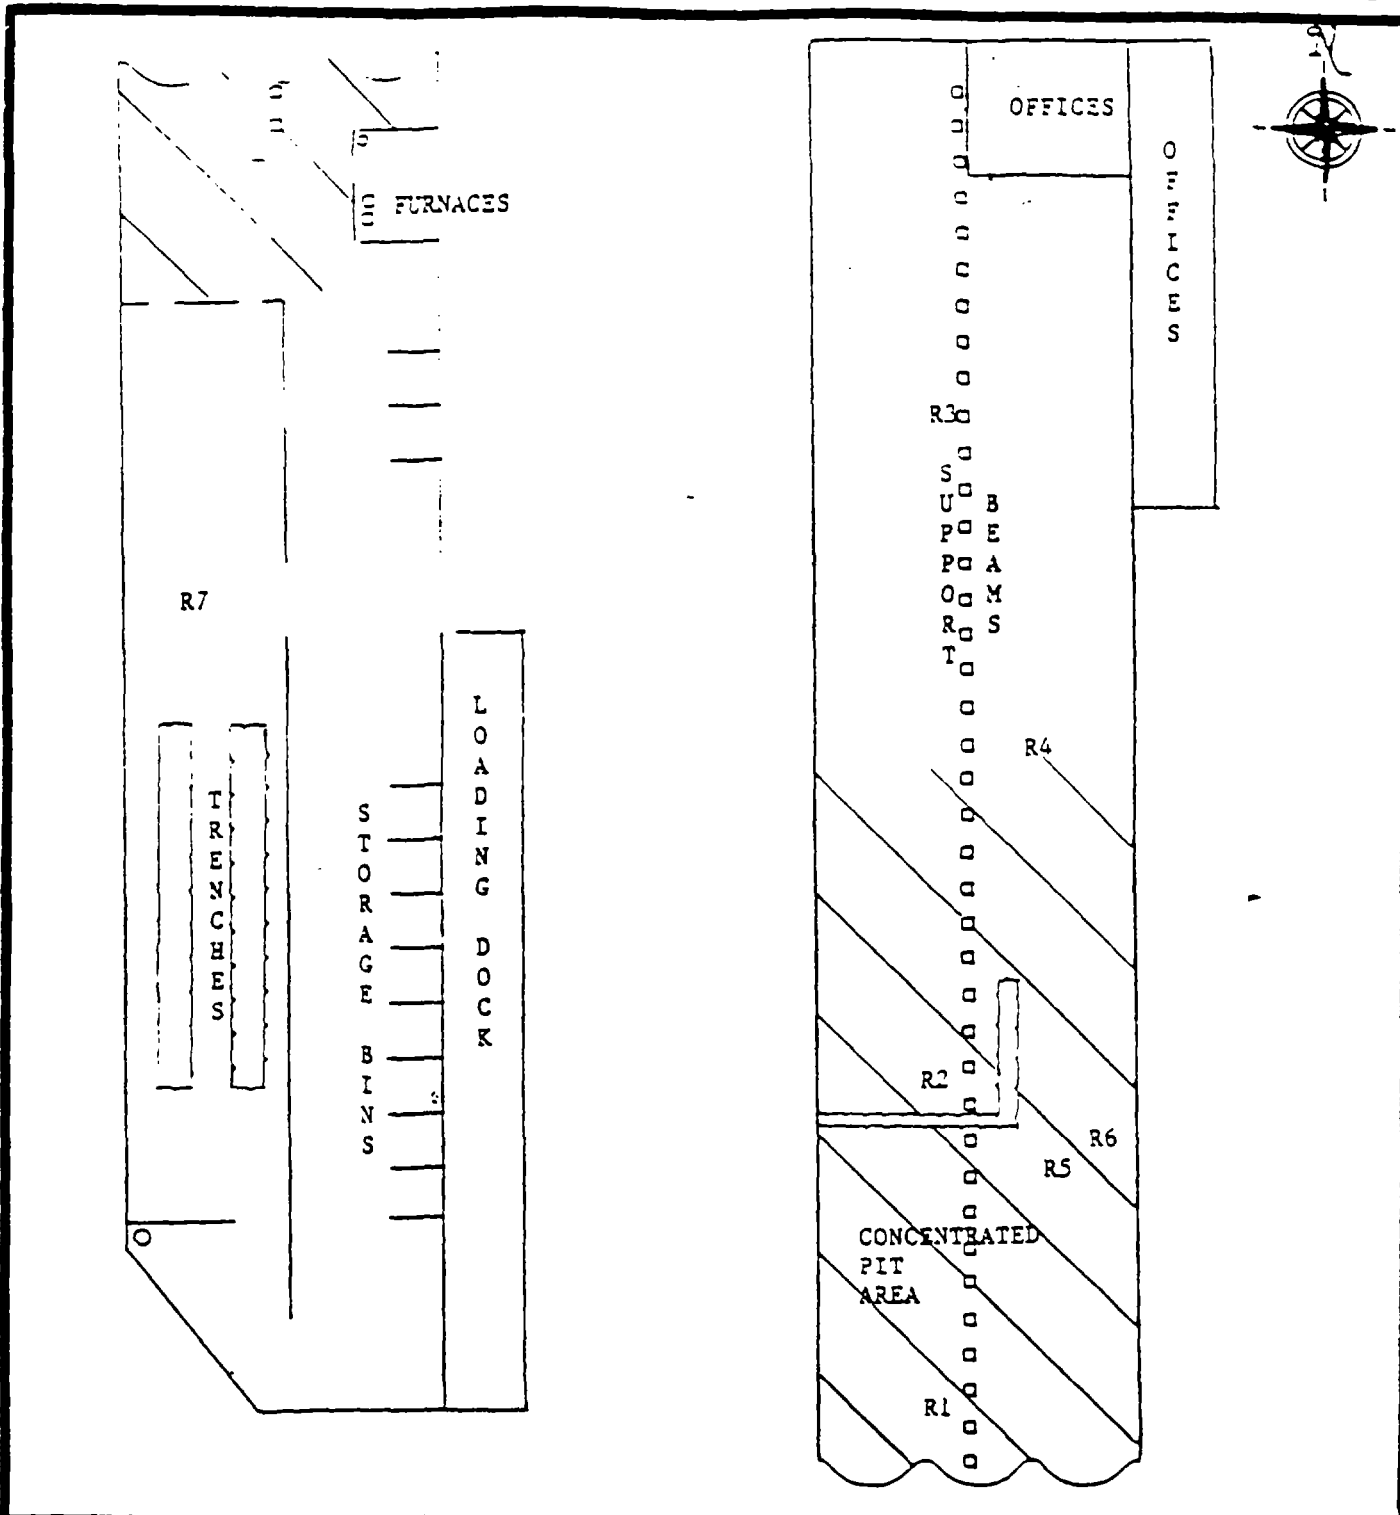
FIGURE 3  
 SAMPLING LOCATION MAP  
 REVERE COPPER AND BRASS  
 DETROIT, MICHIGAN

The PCB analytical results are summarized in Table 1. All of the liquid samples (R1-R6) were below 6.0 parts per million (ppm). The soil sample (R7) collected directly beneath the punctured capacitor, had an extremely high concentration of Arochlor 1242 (160,000 ppm). The National PCB Spill Clean-up Policy (52FR10680) states that soils contaminated by PCBs greater than 500 ppm are required to be removed until a clean-up level of either 10 ppm or 25 ppm is obtained, dependent upon the spill location.

Because the documented PCB contamination is limited at RCB the TAT does not recommend a removal action conducted by U.S. EPA at this time. However, the current owner of the site (City of Detroit CEDD) should be notified of both the PCB contamination and potential for further releases. CEDD should be held responsible for removing all capacitors, and performing an effective cleanup of the contaminated area. The National PCB Spill Cleanup Policy should be used as the appropriate clean-up standard. The CEDD should also conduct a more extensive assessment of the building to assure that no additional capacitors are present on-site. In addition, the suspected asbestos problem should be referred to the Regional Air Pollution Control Agency to confirm the presence of asbestos and take appropriate actions. If the City of Detroit CEDD is unwilling or unable to take responsibility for a removal action, the TAT recommends that the site be referred to the Michigan Department of Natural Resources for further action under Michigan Act 307.

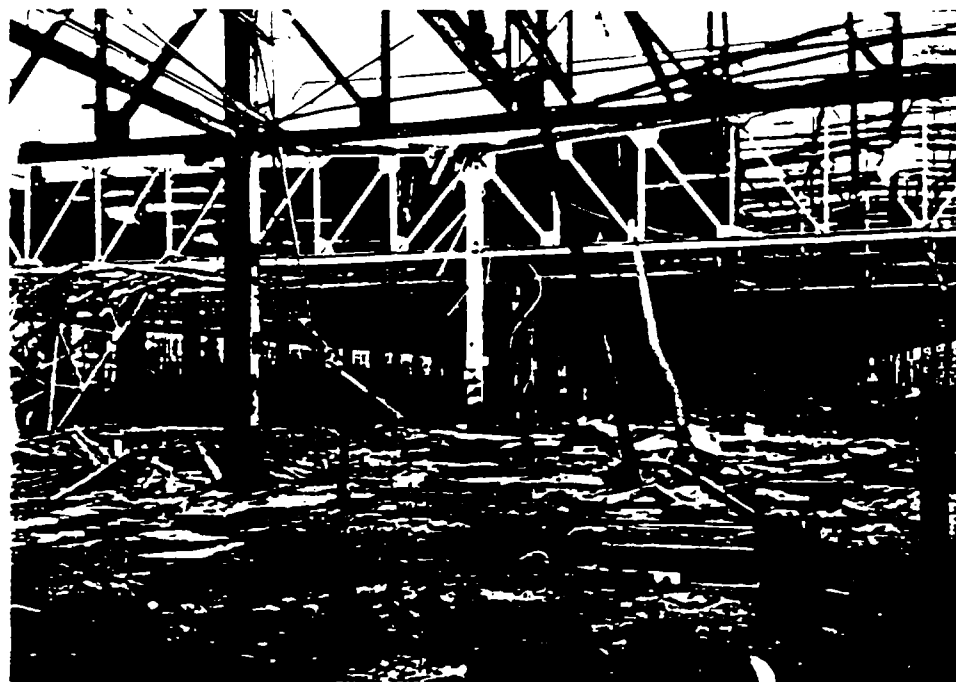
PHOTOGRAPH NUMBER: 26      DIRECTION: N      TIME: PM

The site was suspected of having elevated levels of polychlorinated biphenyls (PCB) because of RCB's handling of scrap copper. The main building is located on the western edge of the property. In the midsection of the building, the roof has collapsed leaving a gap of approximately forty feet. The area adjacent to and east of the building is a zone of scattered demolition debris where extensions to the RCB building once stood. There is a large diked storage tank on the east edge of the demolition debris zone. Four empty offices and support buildings are located on the site. Also, throughout the site, there are considerable amounts of scattered solid waste such as automobiles, mattresses, and refuse.

SUBJECT: FALLEN SECTION OF ROOF IN MIDDLE OF BUILDING

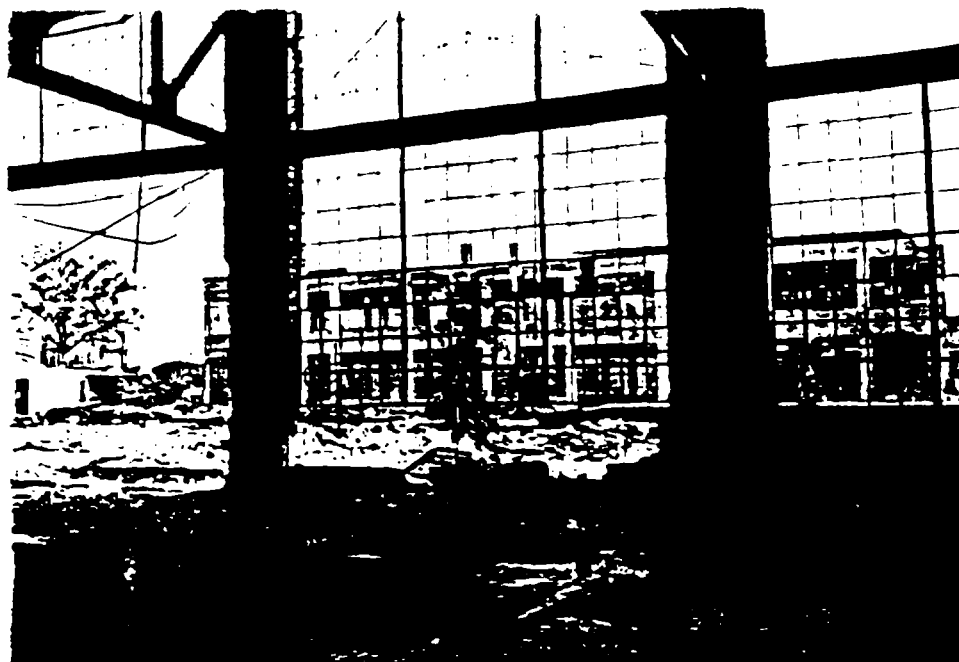
PHOTOGRAPH NUMBER: 31 DIRECTION: E TIME: PM

SUBJECT: BROKEN FOUNDATION IN MIDSECTION OF BUILDING
